ambler
FARM

RAYMOND-AMBLER HOUSE CIRCA 1900

January 2013

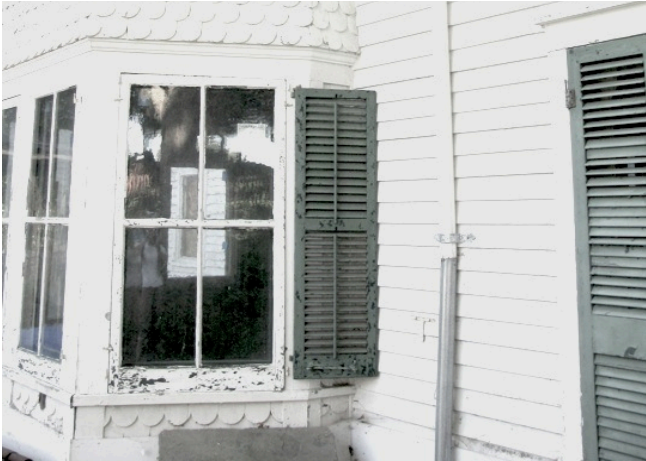
Damaged windows, rotted frames,
worn chipped paint, damaged shutters

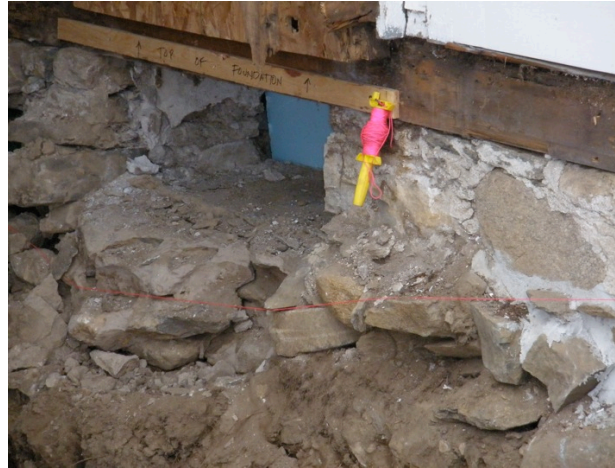
Crumpling field stone foundation

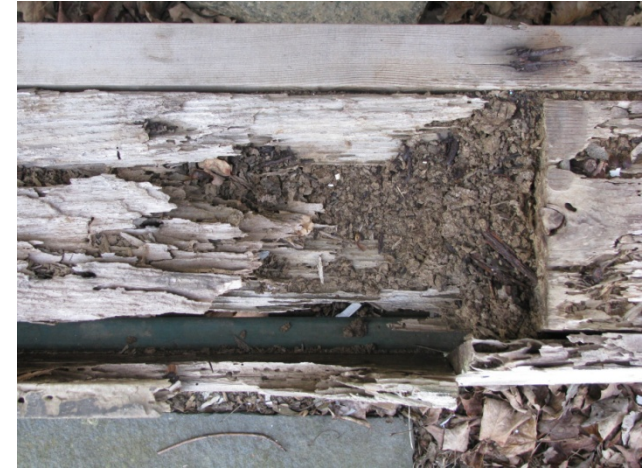
Rotted sill, damaged posts + beams

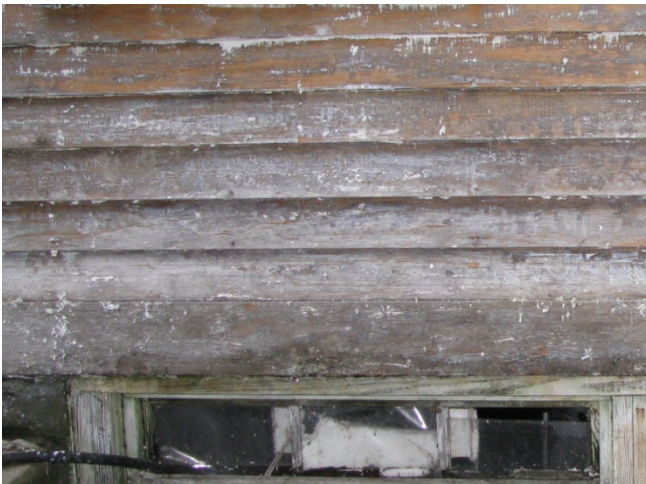
Worn, damaged and rotted clapboard
siding

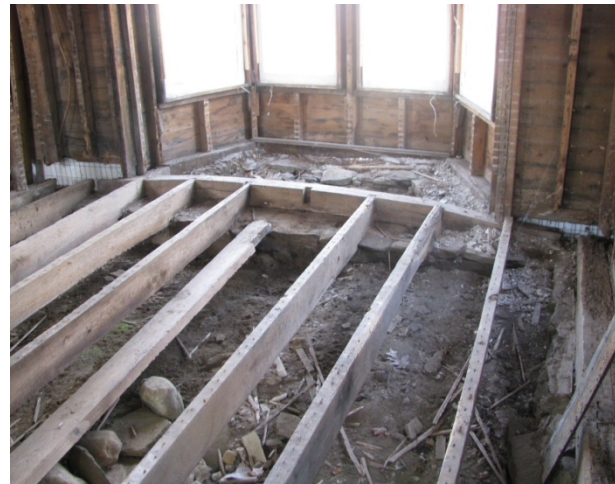
Interior flooring removed; exposes
lack of foundation + subflooring

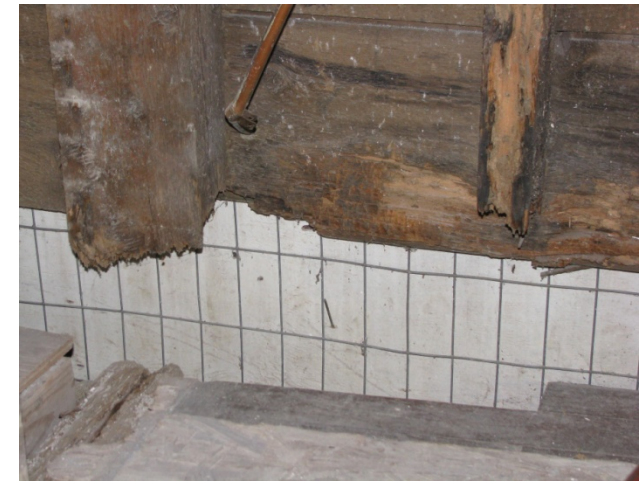
Sill and parts of posts + siding
completely destroyed

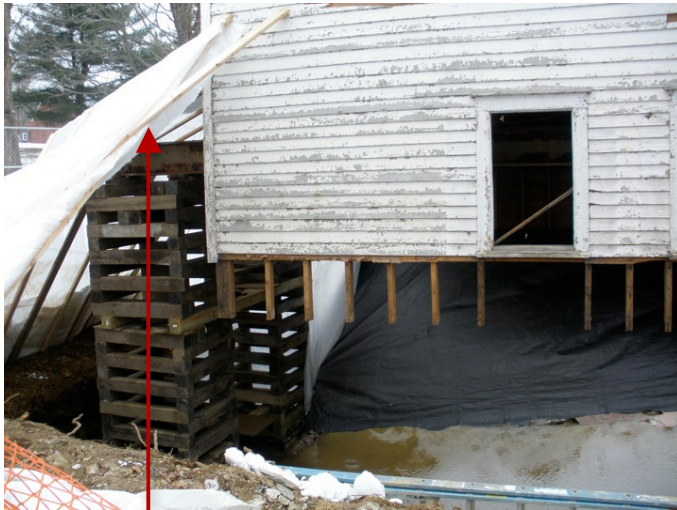
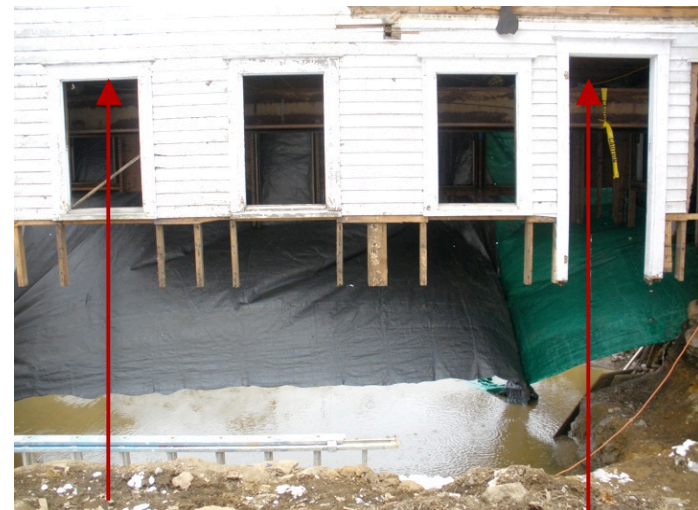
Rear section of house lifted + held in place by steel beam running from the main portion of house to end of rear section. This allows section to remain stable while an 8ft basement and foundation can be built underneath

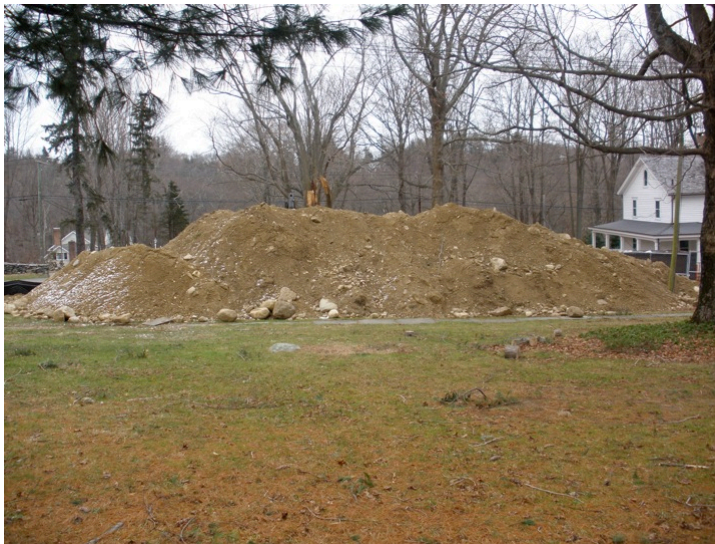
Pile of dirt taken from underneath the rear section

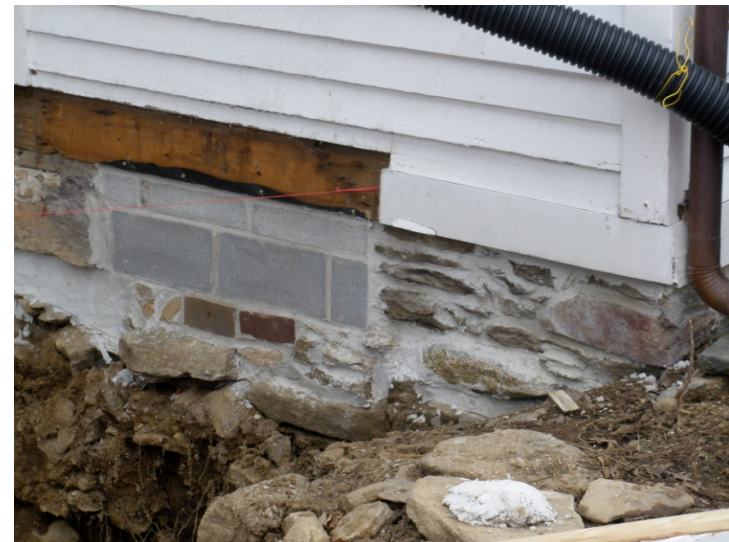
Deteriorated foundation being repaired

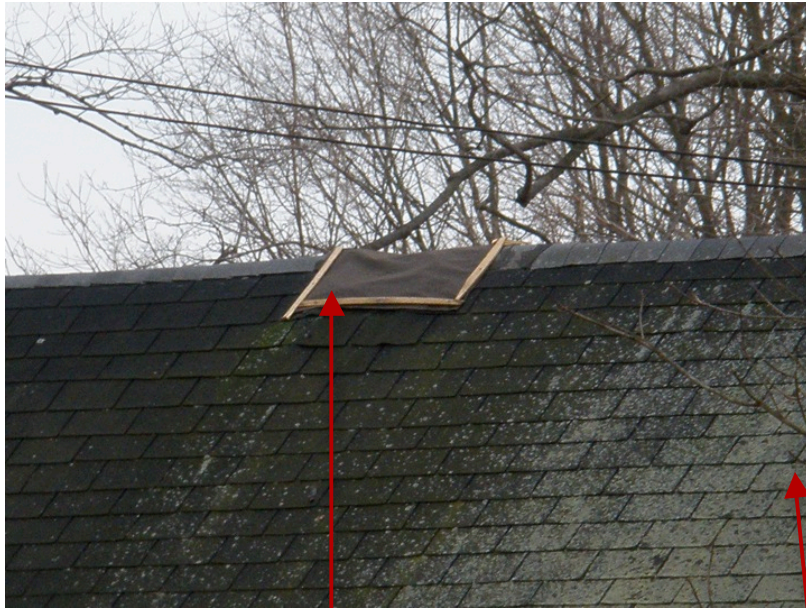
Old wood-burning stove chimney removed; will not be replaced as the house will have central heating. Repairing would have only been done for aesthetic purposes and didn't warrant the cost

A new cedar shingle roof will replace the existing asphalt, which is in very poor condition. The new roof will match that of the front section

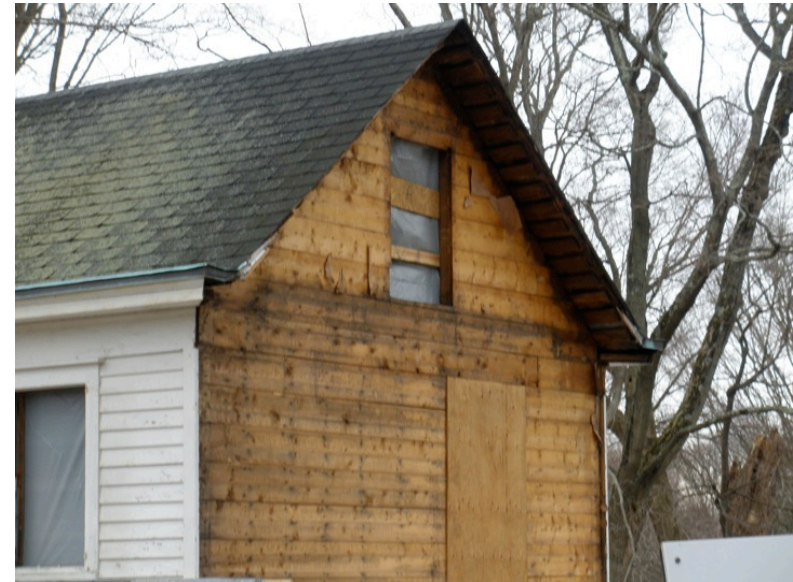
Siding removed at the west end where an enclosed fire stairway will be built, allowing safe, second floor egress which is required by code
